MyM Pro (not Micron)

Release Notes 3.1.1srA2

Release Notes 3.1.1

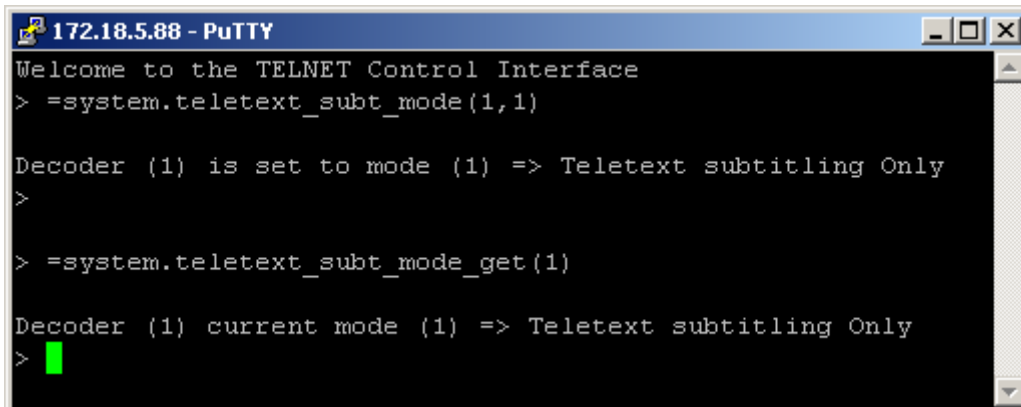
Example in PuTTY:

```
172.18.5.88 - PuTTY
Welcome to the TELNET Control Interface
> =system.teletext_subt_mode(1,1)

Decoder (1) is set to mode (1) => Teletext subtitling Only
>

where x = 1 or 2 or 3 [Decoder 1(4), 2(5) or 3(6)].
